ARE THE NATIONAL ELECTRICAL CODE AND THE NATIONAL ELECTRICAL SAFETY CODE HAZARDOUS TO YOUR HEALTH?

Donald W. Zipse, P.E.
Life Fellow, IEEE

Zipse Electrical Engineering, Inc.
671 Kadar Drive
West Chester, PA 19382-8123

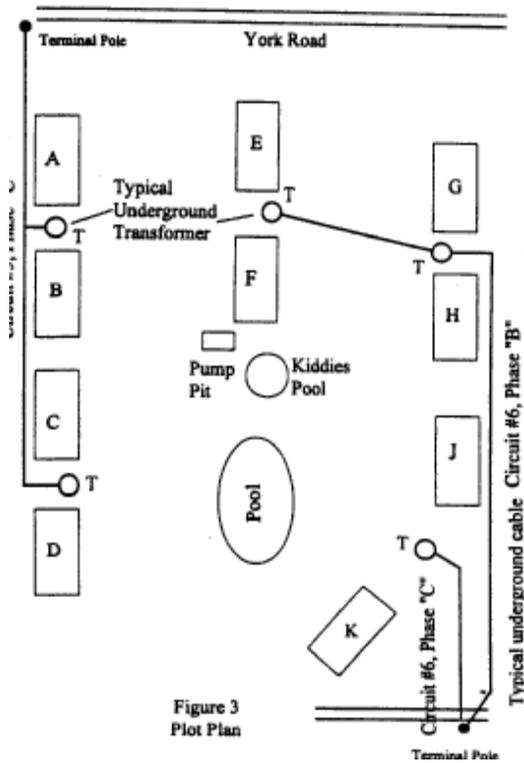
Figure 3
Plot Plan

In late June a manager of an apartment complex converted into condominiums relate a shocking problem with the community swimming pool. (See Figure 3.) The past three years there had been sporadic complaints of persons receiving electric shocks while in the swimming pool. It was the start of the summer and complaints were beginning again.

They were brought up to date on the tests conducted that morning before they arrived. The layout of the electrical equipment was reviewed. Figure 3 shows the ten buildings surrounding the pool. Every two buildings are feed from an underground transformer. There are five transformers for the ten buildings.

The two transformers that supply power to Buildings A, B, C and D have a common feeder. This underground feeder is feed from York Road and is referred to as Circuit #5, Phase C.

Buildings E and F have an underground transformer that feeds the pool in addition to the buildings. On the same underground feeder as Building E and F are Buildings G and H. This circuit is Circuit #6, Phase B. This underground feeder is feed from a street behind the complex at the opposite end of the complex as the feeder for Buildings A, B, C, and D.

The final two buildings, J and K are feed from a third underground feeder, Circuit #6, Phase C. This underground feeder also originates from the street behind the complex.

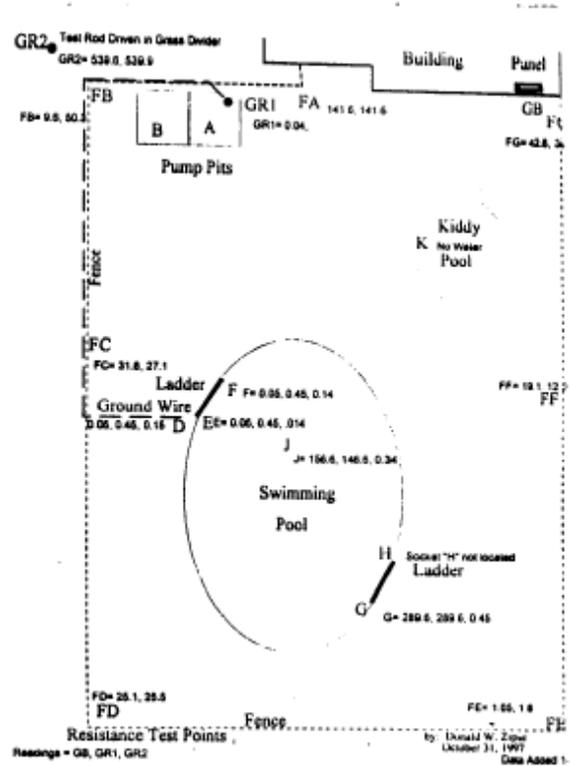
Figure 5
Resistance Test Points and Readings

From each of the main three ground points, test points were selected. Points around the pool such as the ladder sockets, water in the pool, center of the kiddies pool, the corners and center of the fence, etc. A total of 38 readings were taken. See Table 2.

The fence was chain link and no special grounding connections had been made to it. It was difficult to obtain a good connection. The values did change while we watched. We went through taking the voltage and current reading. Then we took the resistance readings. Correlation between the reading was poor.

With the exception of a ladder socket in the pool, the resistance between points was acceptable except the utility still focused on the pool grounding as the problem.

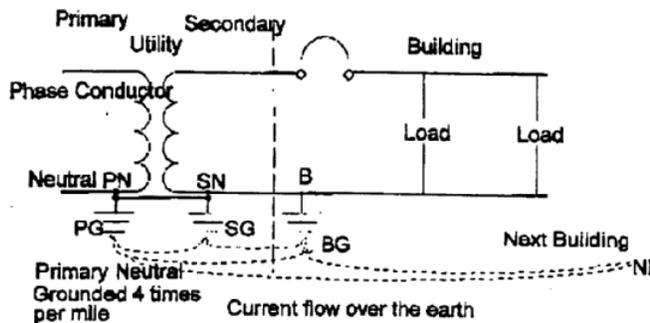
Figure 4
Transformer Connections

It usually comes as a shock to electrical engineers not involved with utilities that the utilities actually solidly connect the primary return side of the distribution transformers to the secondary side neutral connection. See figure 4. The primary return, neutral terminal, PN is connected to the secondary neutral terminal, SN.

This connection of the primary to secondary is made in pole mounted, pad mounted or underground distribution transformers. This connection allows primary current to flow over the secondary neutral-ground conductor. The secondary neutral-ground conductor is grounded, earthed at the transformer, sometimes at the meter and required by the NEC to be connected to earth at the service entrance.

In addition, since the neutral is connected to all the equipment ground connections at the service entrance panel, primary current is now permitted to flow over the equipment ground circuit. Now that we know that a parallel circuit always has some amount of current in all parallel paths, do you want this primary return current flowing uncontrolled over the equipment grounding circuit?

Neutral blockers are similar to a lightning arrester. It is placed between the primary neutral of a distribution transformer and the secondary neutral connection. See Figure 4, PN and SN terminals. The utilities connect the primary neutral to the secondary neutral. This connection allows stray, uncontrolled continuous current to flow over metallic piping, building steel, earth, etc. By installing a neutral blocker, the primary return current is prevented from flowing over the multiple connection to earth that are part of the NEC requirements.

The next request of the utility was to install an inexpensive electrical device used on farms to protect cows from electric shock. It was requested the utility install, in the underground transformer vaults, an \$ 850.00 neutral blocker between the primary neutral transformer winding and the secondary neutral winding.
