Converting an existing house in Dallas for two people with MCS

Keywords: healthy house conversion, MCS housing, MCS renovation

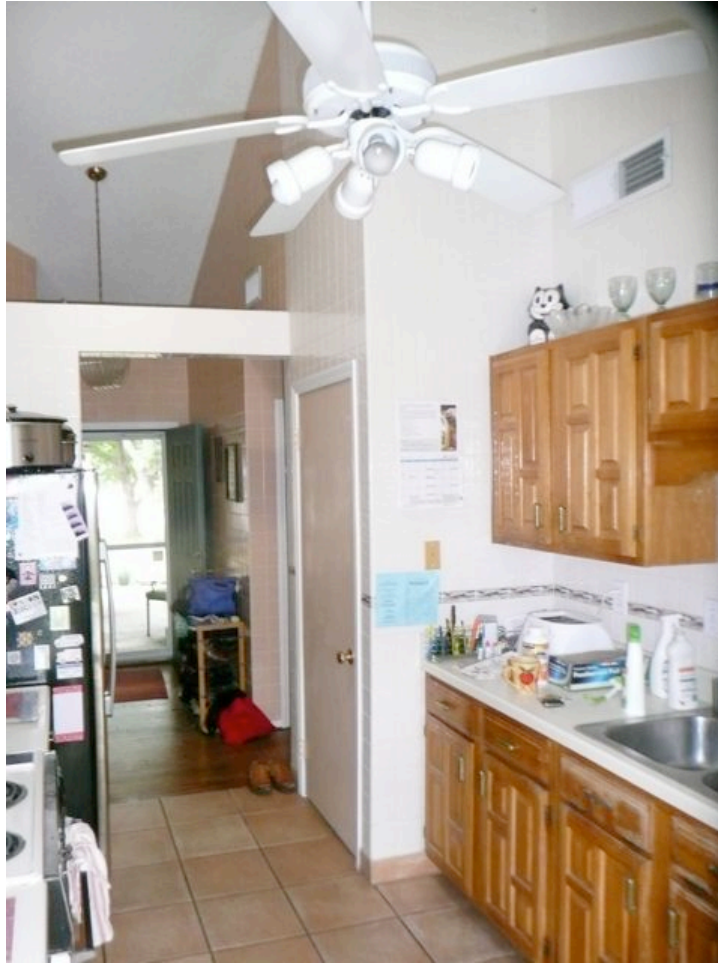
The kitchen/living room has cathedral ceiling, which provides extra airspace to dilute pollution. The walls in the kitchen were tiled to cover up odors, while the original wood cabinets were kept.

The kitchen cabinets had real oak fronts, with fake-wood interiors. The interiors of the cabinets were sealed with aluminum foil. Replacing the cabinets would have been costly.

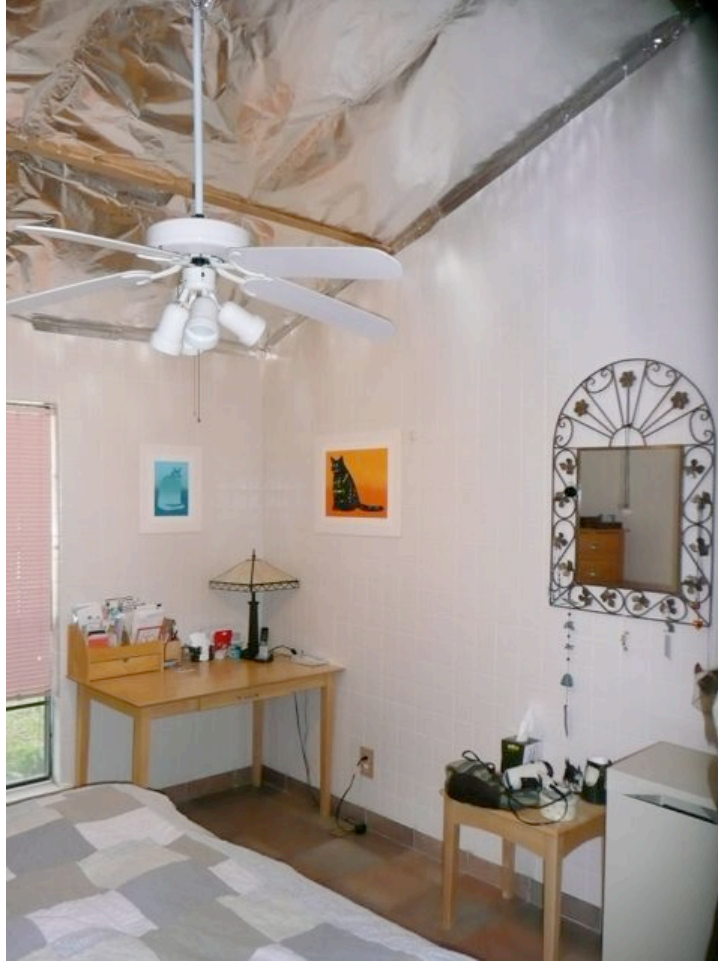
One bedroom with tiled walls and foiled ceiling.

Walls that were still “fragranced” were tiled to cover it up, one at a time. They used the least-toxic commercial grout and thinset, which had to be wet-cured. This added a lot of labor time.

The ceilings in two bedrooms were covered with aluminum foil, held in place with strips of wood.

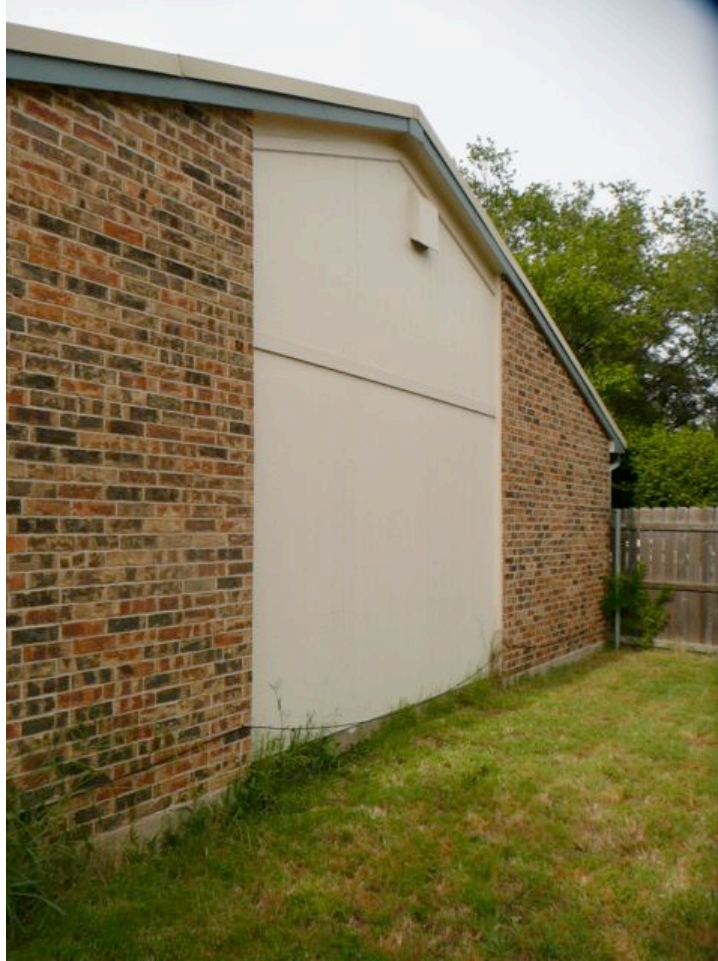
*The exterior is mostly brick, which never needs painting.
The wood panels at the end were replaced with cement siding.*

The wood panels on the side of the house were replaced with cement board siding from James Hardie.
