Converting an existing house in Dallas for two people with MCS

Keywords: healthy house conversion, MCS housing, MCS renovation

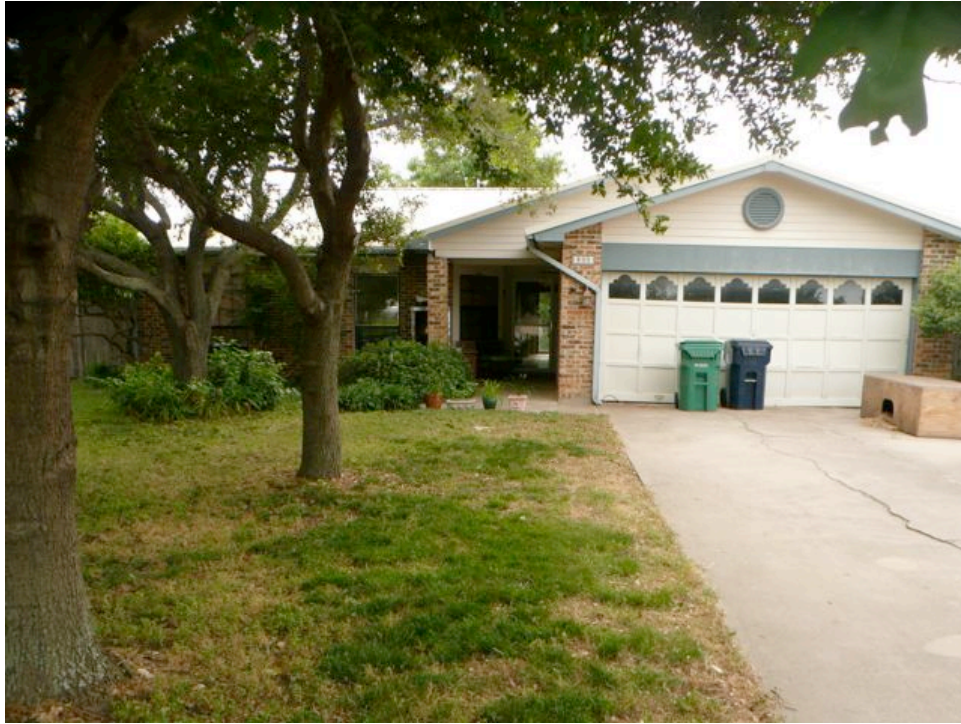
The exterior is mostly brick, which won't need any painting. There were originally a few wooden panels on the sides. The inside is gypsum drywall, which has a tendency to absorb fragrances like a sponge.

*The exterior is mostly brick, which never needs painting.
The wood panels at the end were replaced with cement siding.*

The wood panels on the side of the house were replaced with cement board siding from James Hardie.
