The House of Good Air

A couple from California built a comfortable and MCS-safe house in rural southern Arizona.

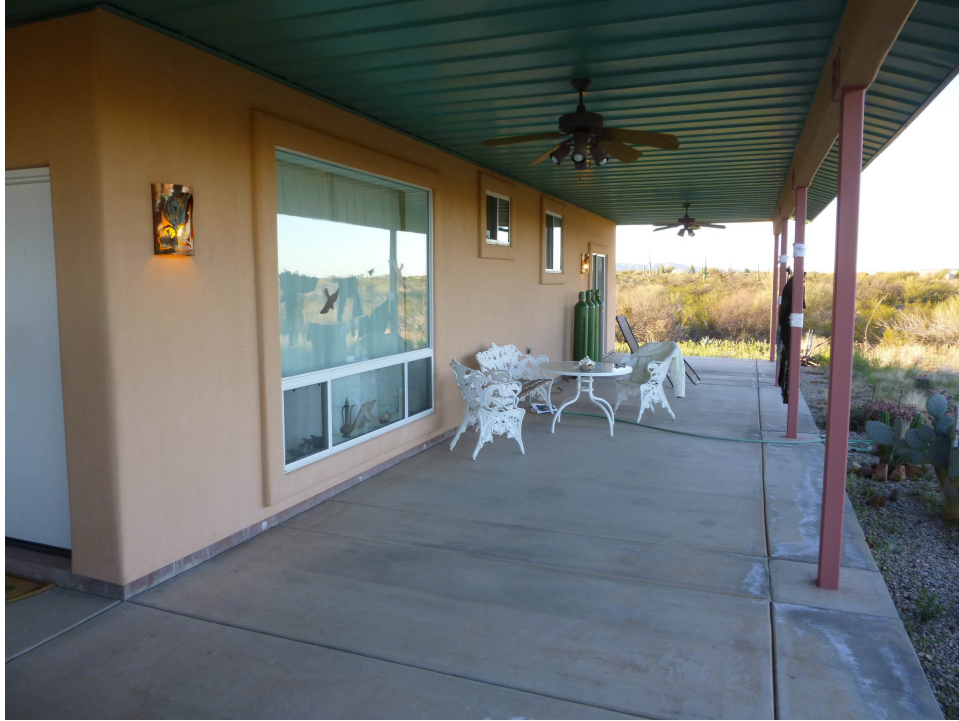
The covered back porch

A deep covered porch runs along the whole rear side of the house (west side), where it provides a private outdoor space and shades the house against the afternoon sun.

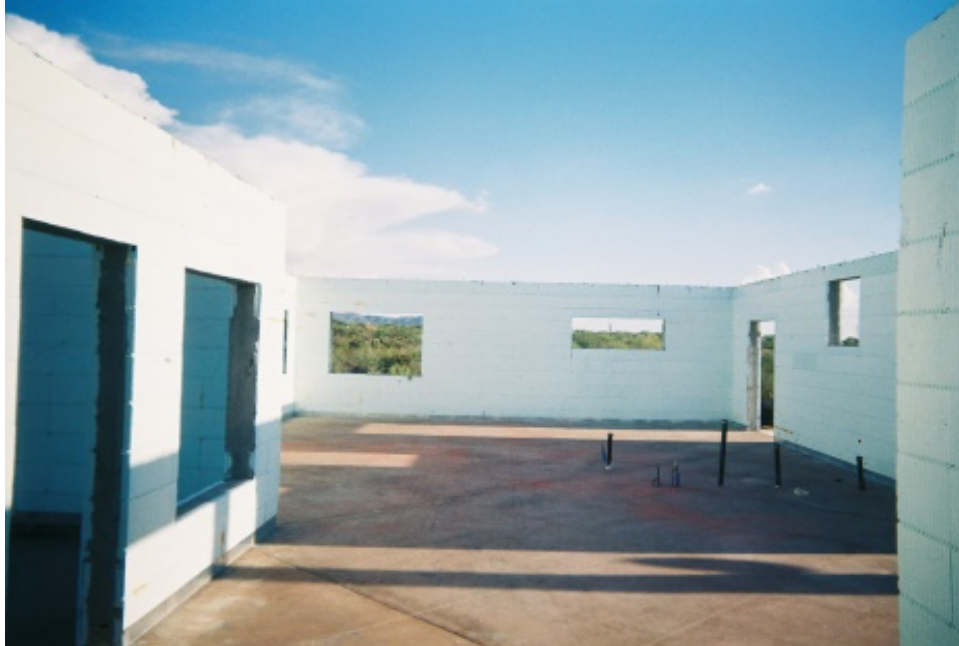
The polystyrene Integrated Concrete Forms create strong airtight outer walls. The floor is tinted and buffed concrete.

The outer walls were built of a type of polystyrene foam blocks called Integrated Concrete Forms. The blocks were hollow and once the walls were erected the cavities were filled by concrete reinforced with rebar. This created a very strong, airtight and somewhat insulated wall. The walls were later further insulated on the inside.

Making the outer walls separate from the interior walls, and using such solid materials, made the house very airtight. This is very helpful in preventing air pollution from wildfires or human activities from entering the house, besides making the house more energy efficient.

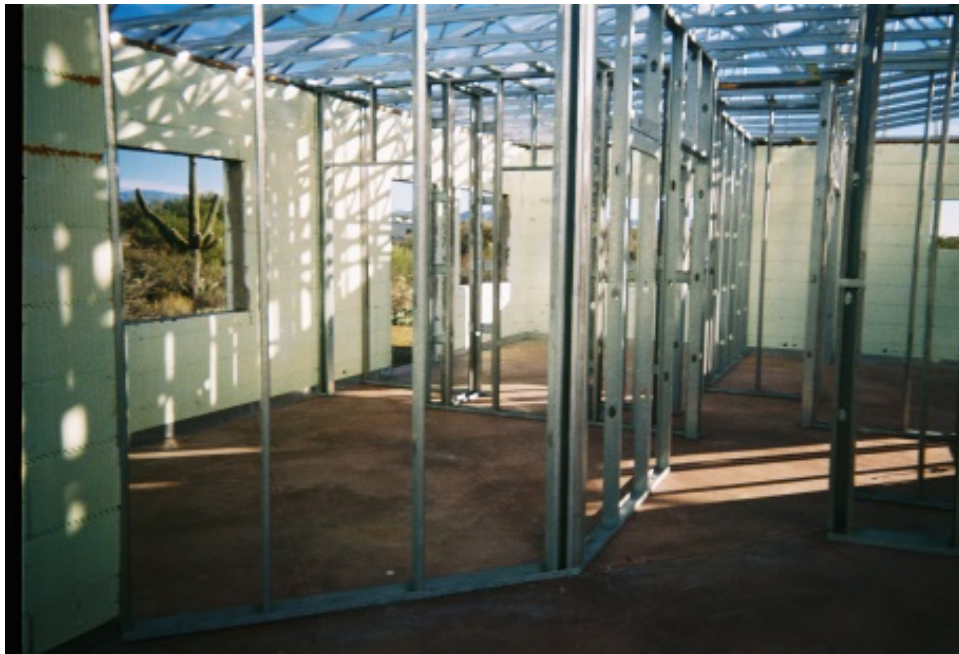
The interior walls were made of steel studs that were degreased.

The interior walls were framed using steel studs. The steel was cleaned of manufacturing oils with a TSP detergent before the studs were installed. This was very labor intensive.

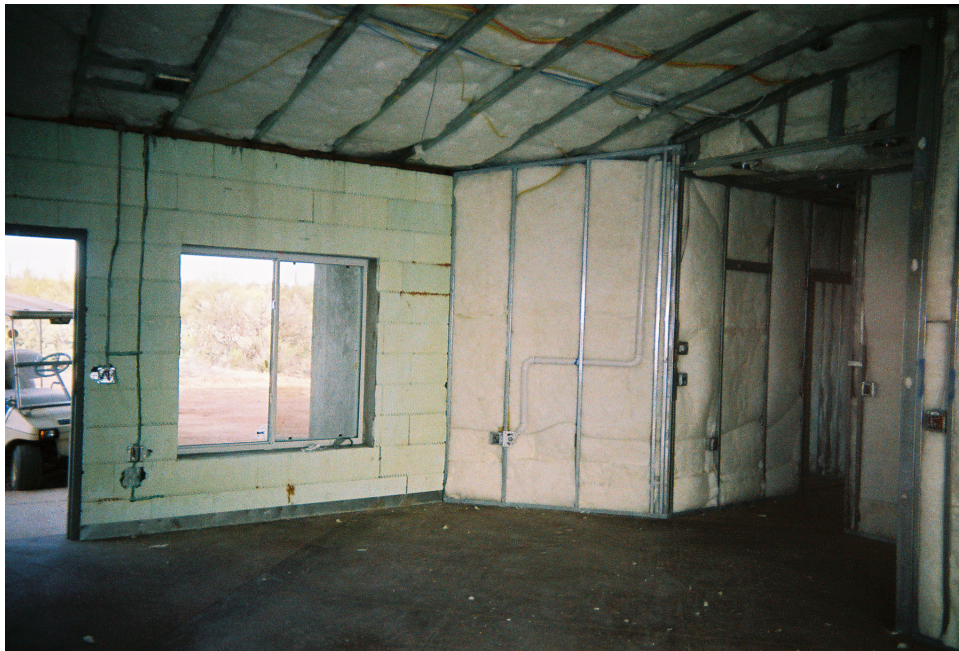
The walls and ceilings were insulated with formaldehyde-free fiberglass.

Studs were also mounted on the inside of the exterior walls to further insulate them. Formaldehyde-free fiberglass was mounted between these studs and then covered with formaldehyde-free gypsum drywall.

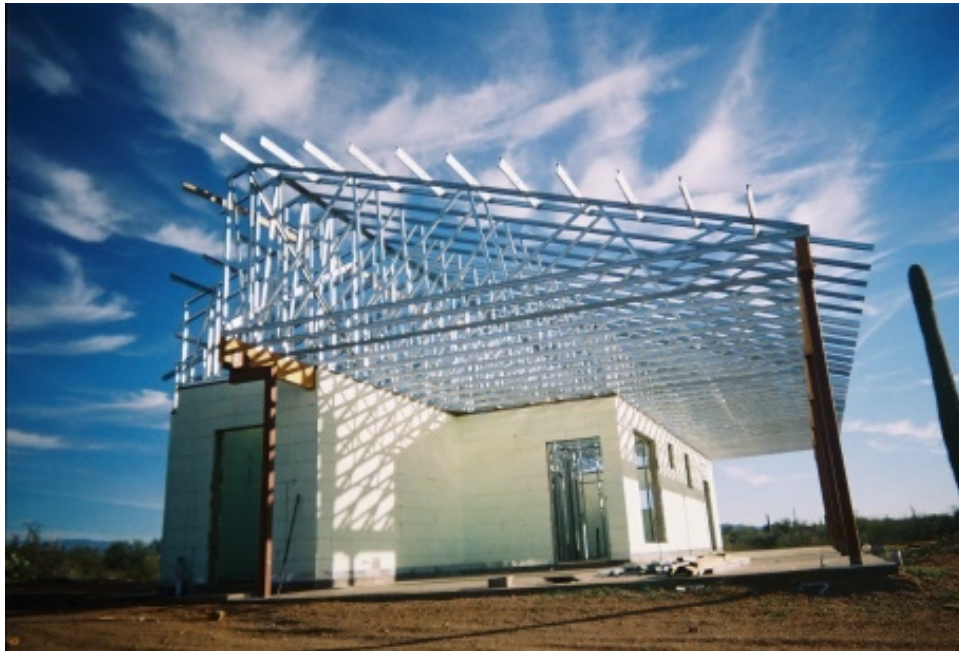
The steel trusses.

The roof was mounted on steel trusses. The roof material was steel panels with standing seams, which creates a very strong and durable roof. They did not want to use the standard toxic plywood decking under the roof and it wasn't necessary with these strong steel panels. They simply covered the top of the trusses with a vinyl underlayment (recommended by the manufacturer of the roof panels), and then mounted the panels on top. No purlins or decking were used.

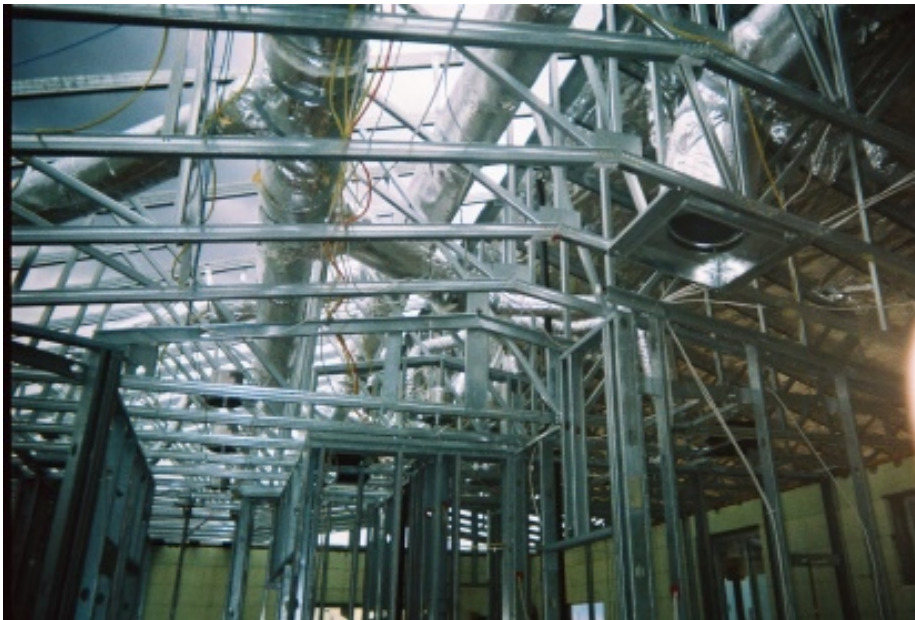
Rigid steel air ducts.

The air is transferred through rigid steel air ducts that were degreased before they were installed, to remove manufacturing oils. Extra-large ducts were chosen to reduce the noise from the ventilation system. The ducts were sealed with aluminum tape. Flexible air ducts were not used since they are impossible to clean.

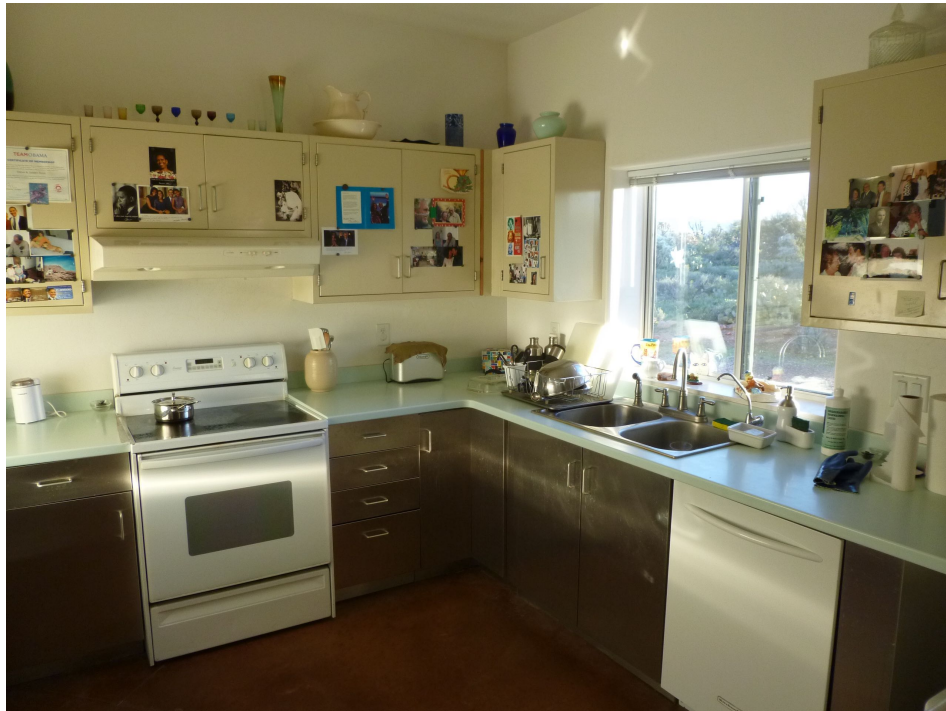
The upper kitchen cabinets are of powder-coated steel, while the lower cabinets are stainless steel.

The kitchen cabinets are of stainless steel and steel with a baked-on powder coated paint.
