Beautiful, Healthy House Built of Natural Materials on a Modest Budget

This beautiful house is built of natural materials in the southwestern style for a man with severe chemical and electrical sensitivities. The owners saved a lot of money by using materials found on the land, recycled materials and by living frugally.

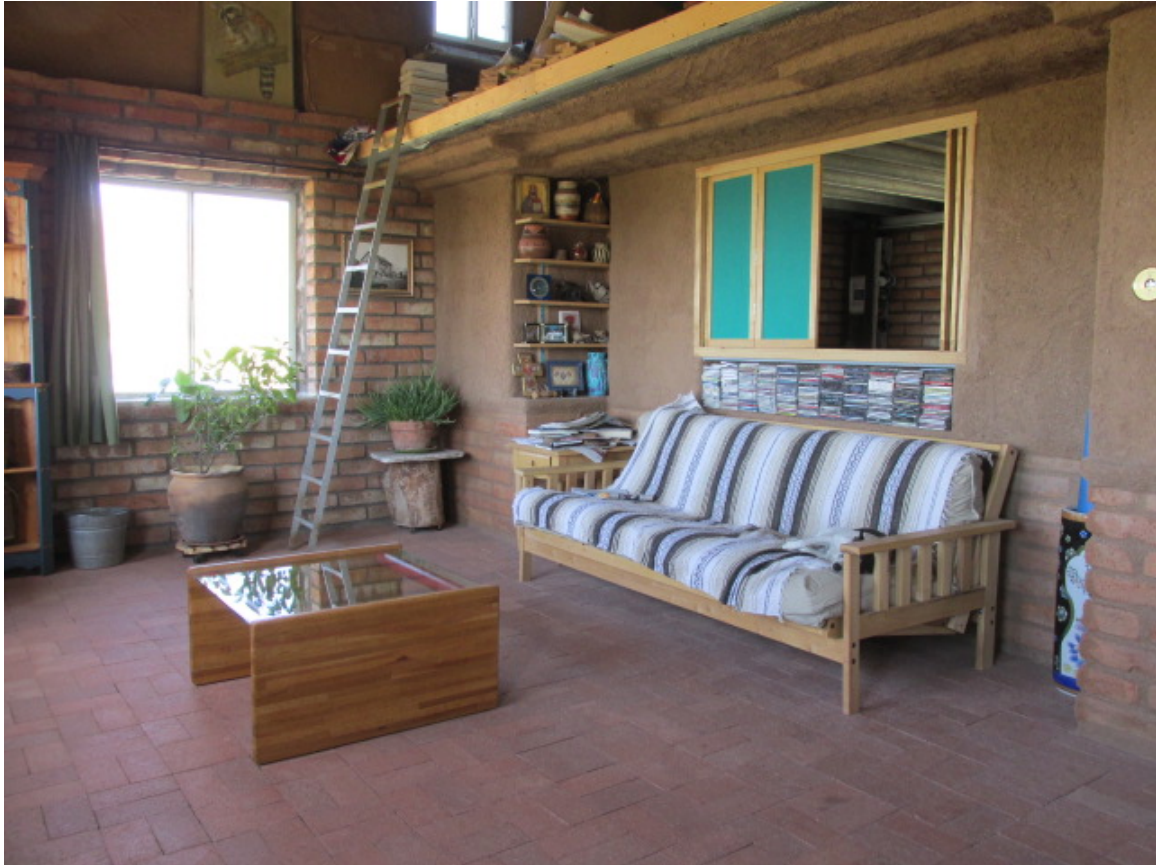
*The living room with a ladder to the loft.
The blue shutters provide ventilation to the bedroom.*

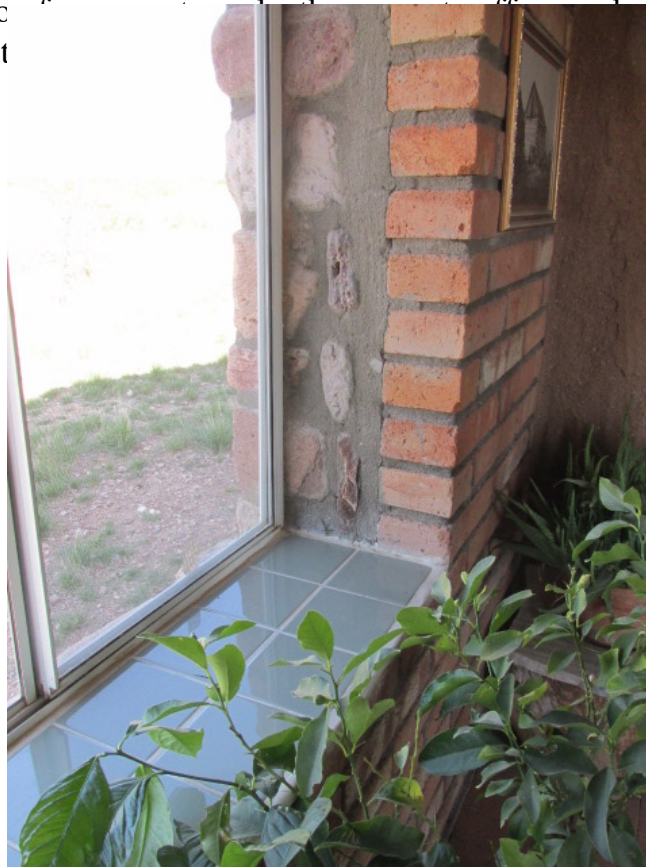
The rock on the in the windows.

There is an inner and an outer wall, with a cavity that is filled with insulating perlite. The inner wall is made of kiln fired adobe bricks that Jeff was able to get cheaply in nearby Mexico. Sun-hardened adobe bricks were not used, since they

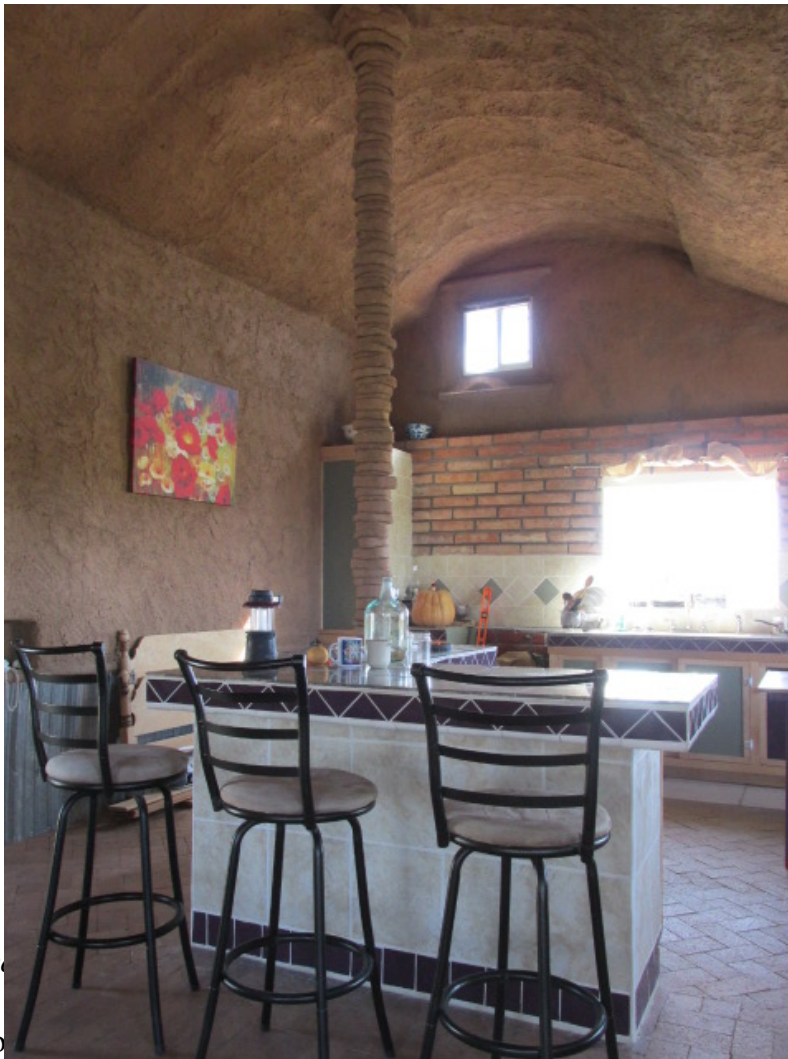
The ceiling is made of adobe.

Jeff attached chicken wire to the underside of the purlins with bamboo to support it under the peak and give it a rounded shape. He used chicken wire instead of lath because he got an old roll cheaply and the old roll no longer had any manufacturing oil left on it. He plastered the ceiling with a mixture of clay and grass stalks he gathered for free from his own land. He avoided doing any plastering during the winter, as the house was too cold for the plaster to dry fast enough. He did not want it to get moldy.

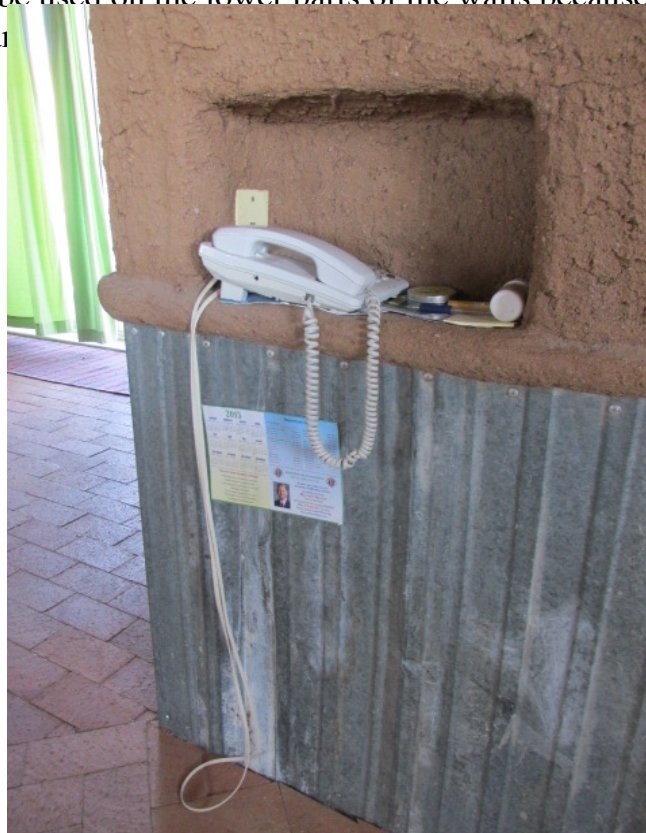
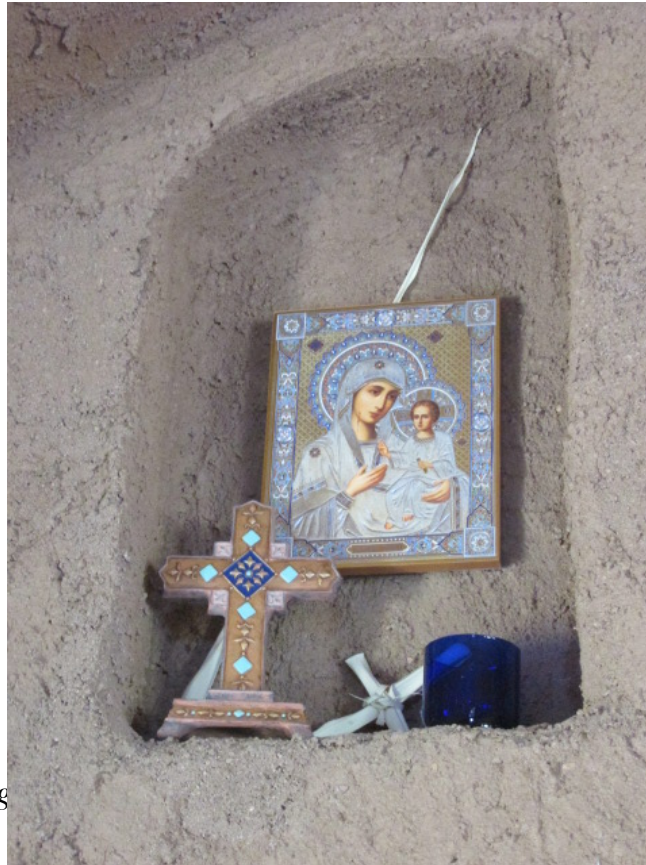
Building *n a wall.*

The interior walls are mostly built of steel studs. The lower part of some walls is covered with weathered galvanized steel plates that Jeff got from a recycler. Other parts have fired adobe bricks for the lower walls. The upper part of the walls is the same clay and grass stalk stucco as on the ceiling, but here using regular lath that was washed in soapy water to remove the manufacturing oils.

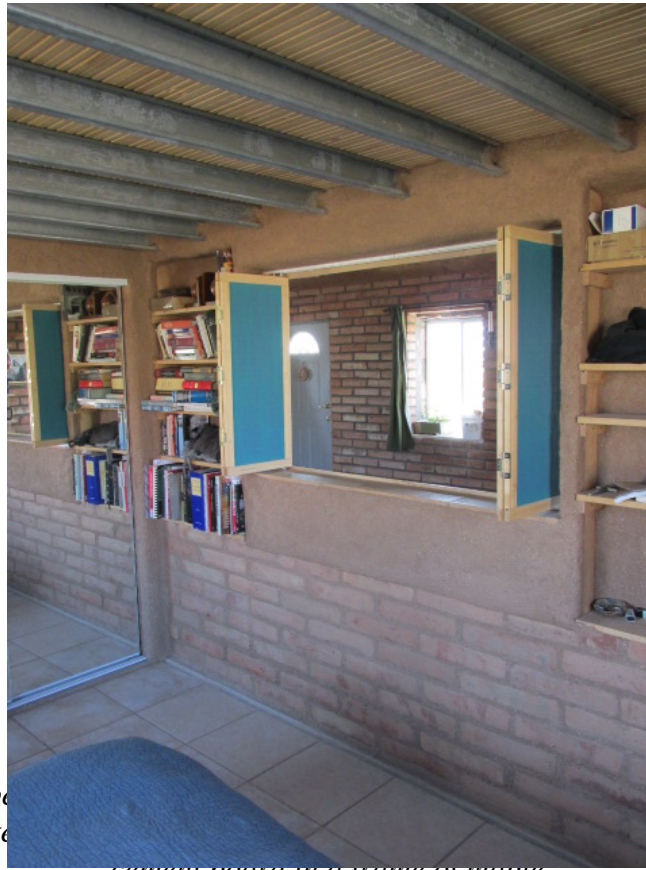
The bedroom ceiling of steel studs with a floor of maple floor planks and a window with a teal door. The walls are made of brick and the floor is tiled.

The bedroom has a separate ceiling with a loft above. This ceiling is made of heavy-duty steel studs with a floor of maple floor planks. Maple was chosen because it is the least odorous wood. Maple is expensive but Jeff was able to get a great deal on some maple flooring, which he also used for several other projects.

He avoided installing a subfloor/ceiling by making sure each of the maple planks ended on top of a steel ceiling support.

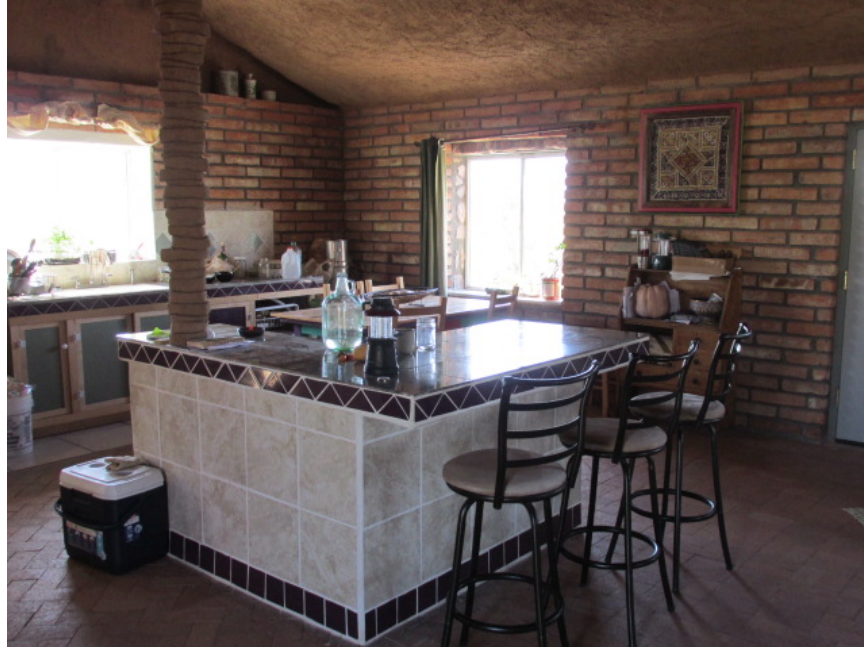
The kitchen is large with a counter against the outside wall and an island in the middle. The cabinets are built of steel studs, cement boards and tile. The countertops are either granite or tile on top of cement board. The cabinet doors are painted cement board in a frame of maple flooring. It is all handmade.
