Safe in a Secluded Valley

by Andrew Eriksen

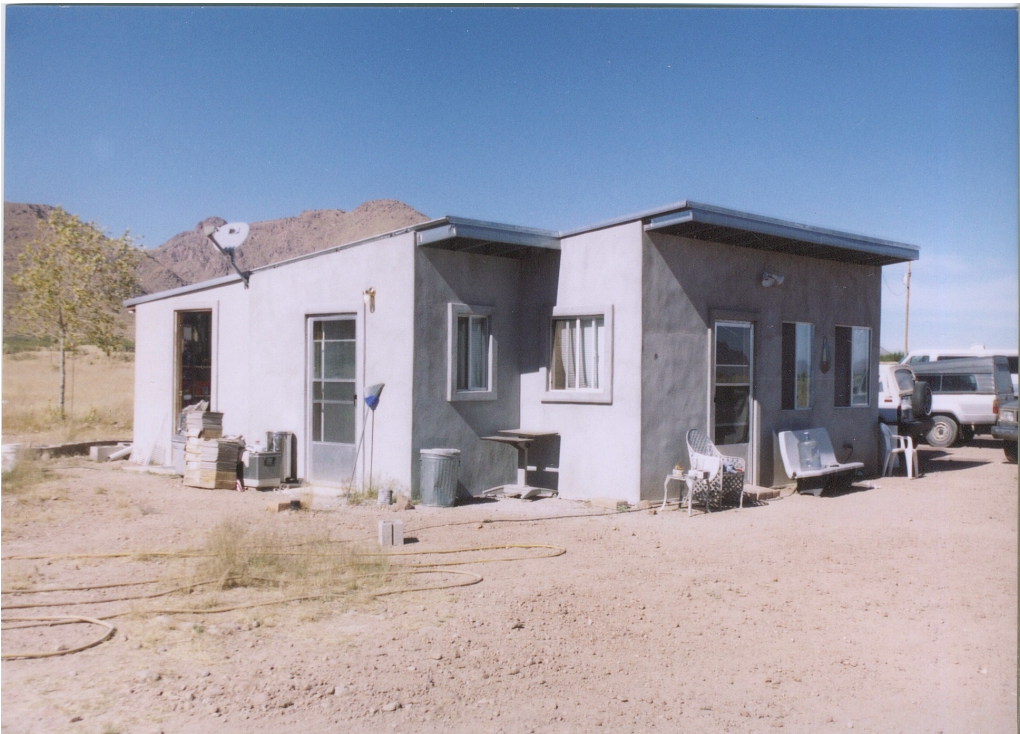
The Osgood's house, when only the first phase was completed.

The married couple first built a small one-room house with a tiny bathroom to live in while building the rest of the house. This original house is now the kitchen.
