A Swiss apartment building for people with chemical and electrical sensitivities

In a quiet suburb of Zurich, Switzerland, lies a four-story apartment building that is a pioneering project in design for people with chemical and electrical hypersensitivities.

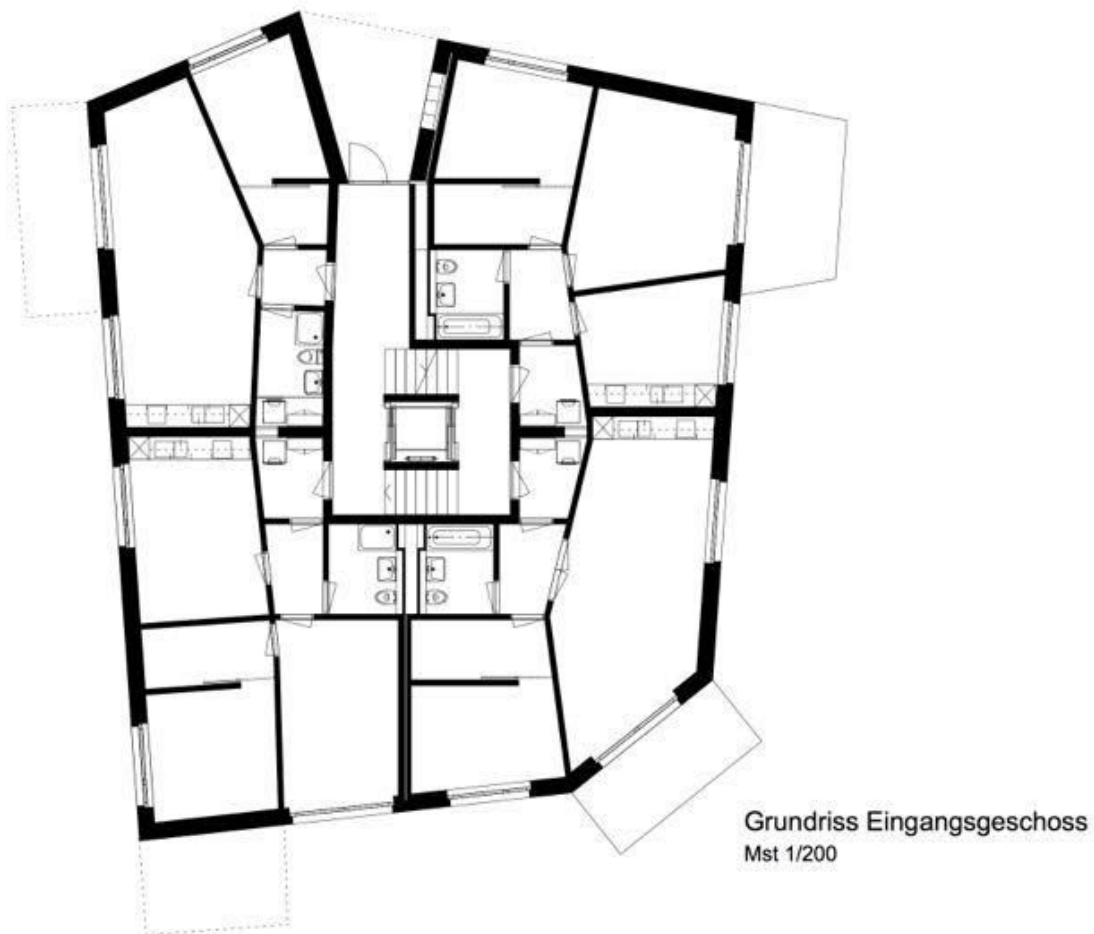
*Floor plan for the ground floor with four apartments.
Courtesy Andreas Zimmermann, architect.*

The building has four stories, each with four apartments, except the top floor, which has three. The apartments have from 1 to 3 bedrooms and are from 50 m² (480 sq ft) to 87 m² (840 sq ft).

The building has three concentric zones:

- central stairwell
- utility ring
- living spaces

The zones are designed so the places the occupants spend most of their time are also the most protected against air pollution and electropollution.

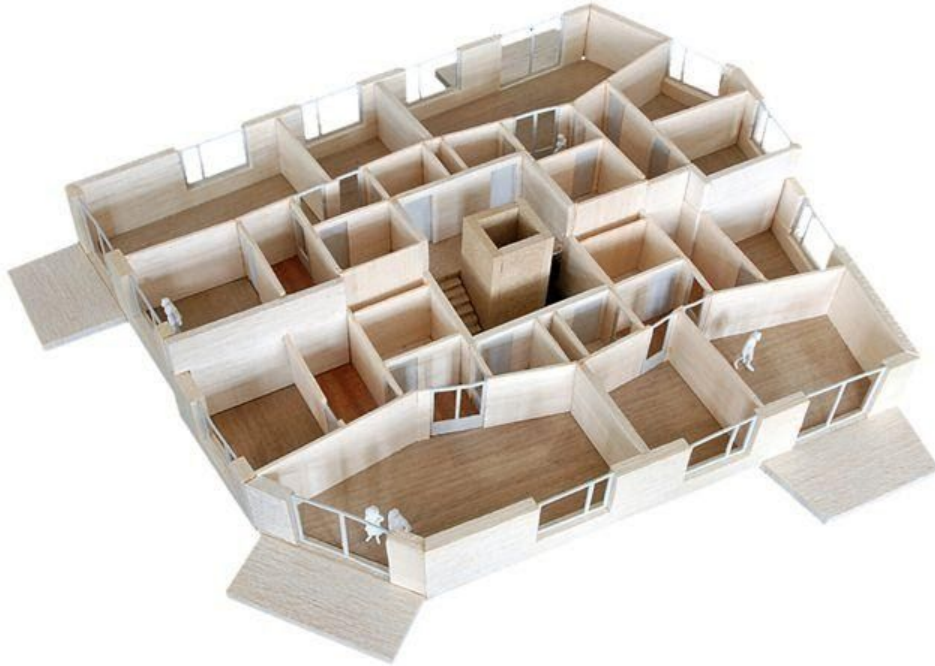
Model of a middle floor.

The central stairwell contains stairs and an elevator. All sorts of people may traverse this area, including visitors, maintenance people and delivery services. These people may use wireless devices and will often be scented.

The utility ring is a buffer zone between the central stairwell and the living space. It contains an airlock, hallway and bathroom for each of the apartments. The idea with the airlock is that people can arrive home with stunk-up clothes, which they can leave in the airlock before entering the rest of the apartment. People use outer garments much of the year in Switzerland, so it is important to have a place to hang them where they do not cause problems. The airlock also protects against fumes from the stairwell.

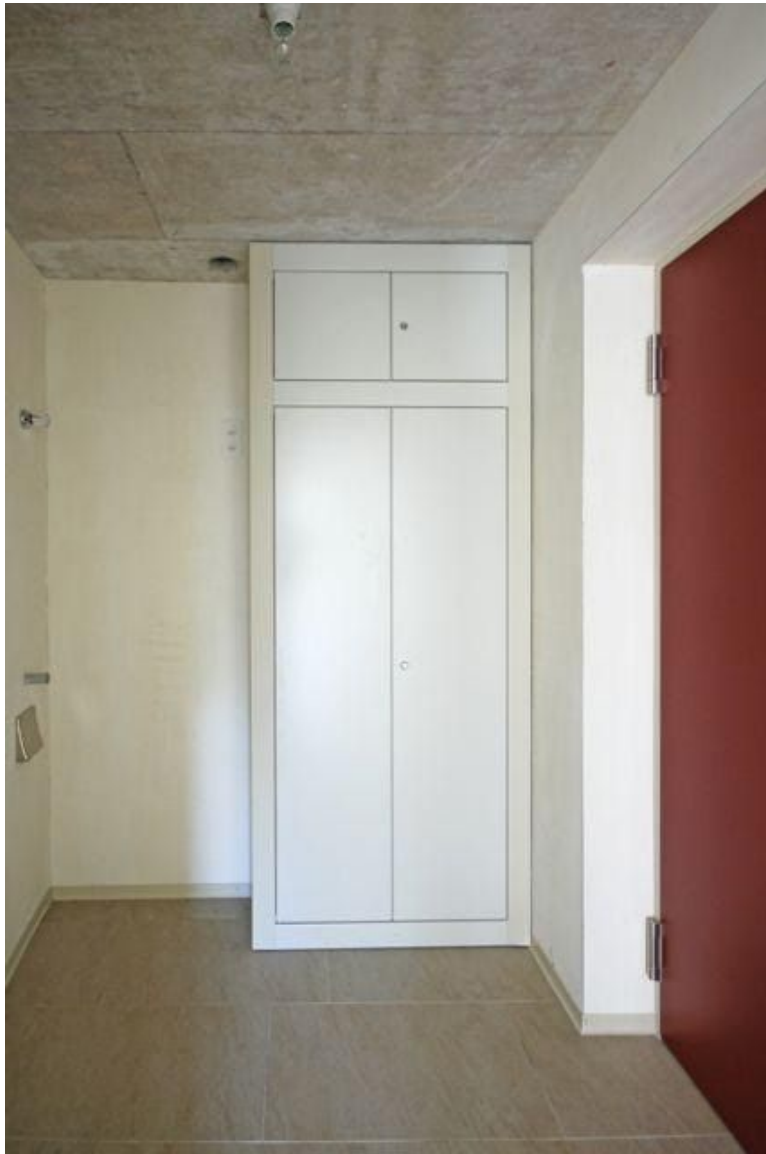
*Airlock with utility closet, entrance door and air vent in ceiling.
The washing machine has not yet been installed.*

The airlock has hookups for a washing machine, so a person can simply strip off the clothes and deposit them in the washer before entering the apartment.

A suction vent in the ceiling of the airlock creates negative air pressure, so any fumes in the airlock will not enter the apartment.

The airlock has a wall-to-ceiling utility closet, through which passes the utility lines to the floors above. If maintenance is needed, the service technician will only need to enter the airlock and not the rest of the apartment. Locating the closet here also keeps the electrical wires at the maximum distance from the living area (all the wiring is also shielded).

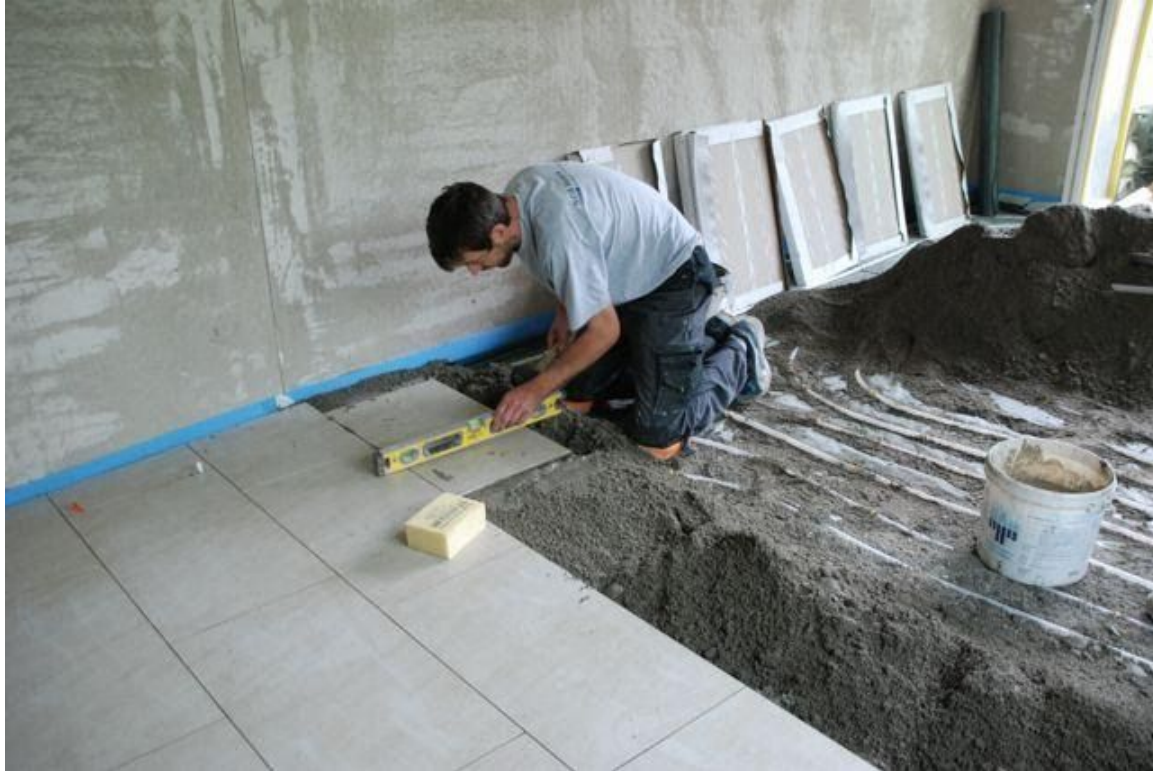
Installing the floor tiles with thickset mortar.

The plastic tubing for the radiant floor heating system is placed on top of the raw concrete subfloor and then covered with a thickset mortar. The floor tiles are installed on the thickset mortar.
