## Converting an office suite in Texas to be safe for people with MCS

## 2 *Converted office in Texas*

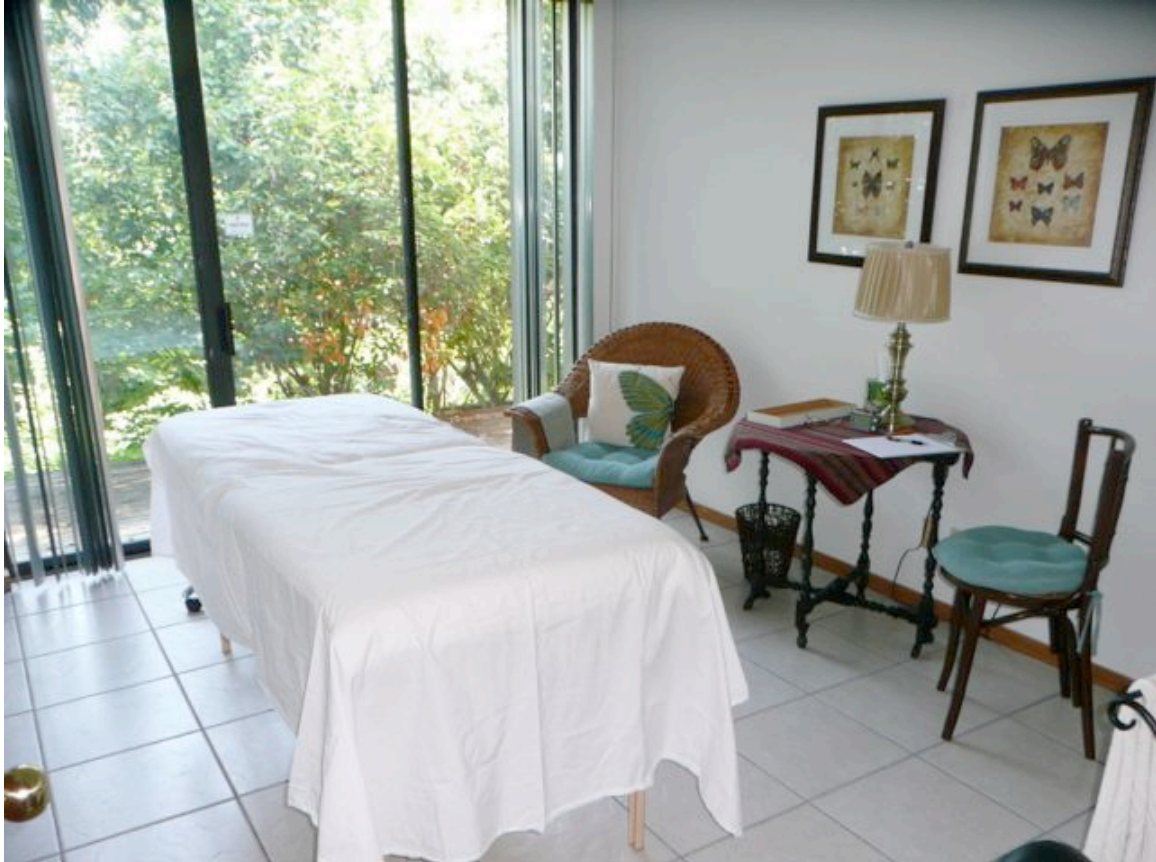
The ceilings were not painted. They were already covered with a “popcorn” textured paint which would be difficult to paint or to replace, so it was left in place.

*A treatment room*

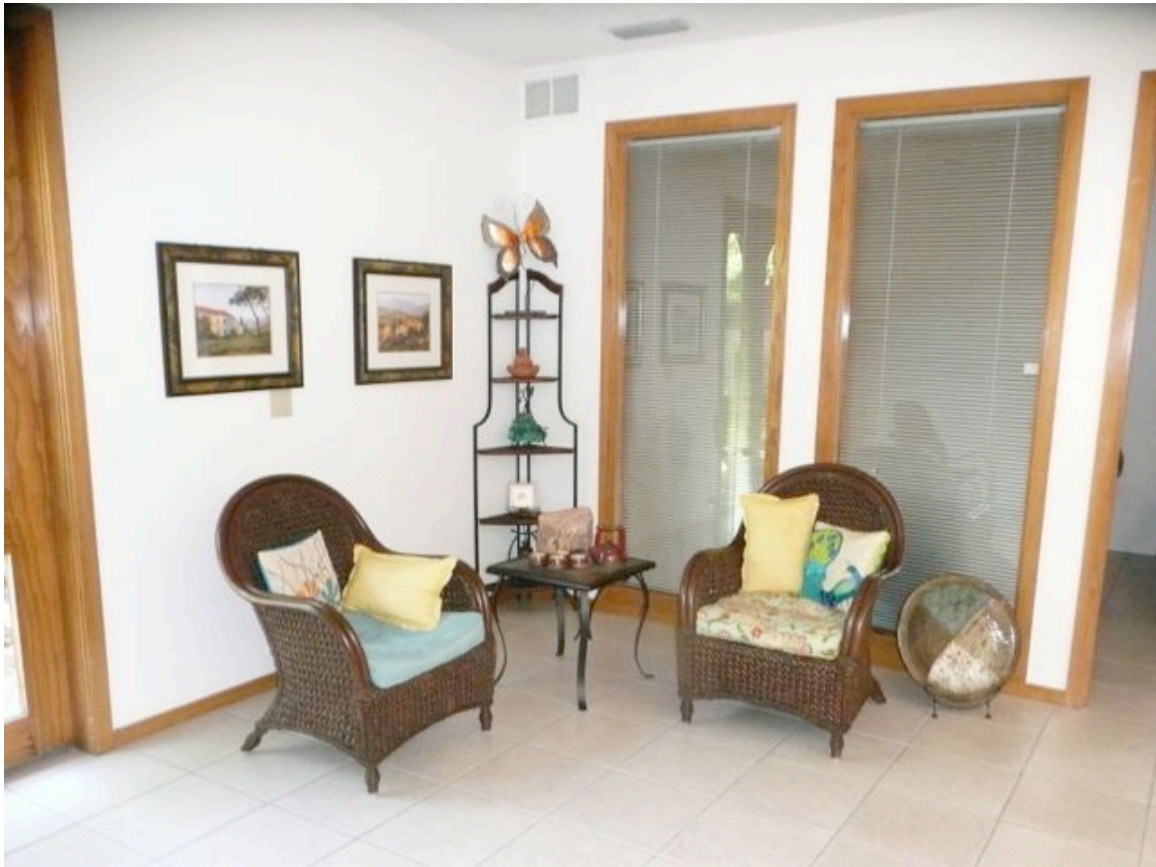
The furniture and decorations are all of natural, materials, i.e. steel, glass, stone, ceramic and genuine wood. They were all purchased well ahead of time and left to offgas in the director’s garage for at least a year.

*A corner of the waiting room*
