## Military radar stalls car

# A giant military radar interfered with the electronics in a nearby car every time the radar beam pointed at it.

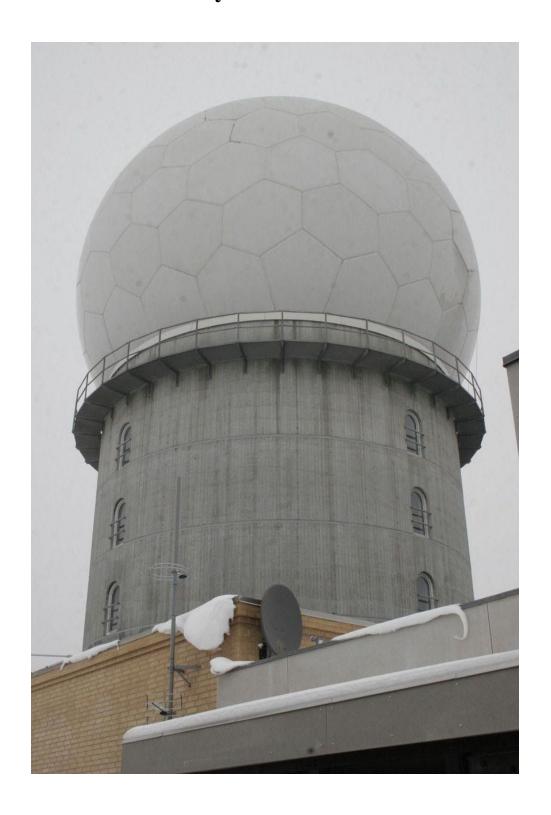
A powerful military radar is located at Skagen, near the northern tip of Denmark. Here it watches over the open waters between Denmark, Norway and Sweden.

The antenna is 77 square meters (740 sq ft) large and weighs 30 tons. It is placed inside a large fiberglass dome on top of a 22 meter (68 foot) concrete tower.

It turns five times a minute, taking 12 seconds for its powerful beam to scan the full horizon.
